DECEMBER 1964

THE NAVAL AVIATION SAFETY REVIEW

The takeoff...

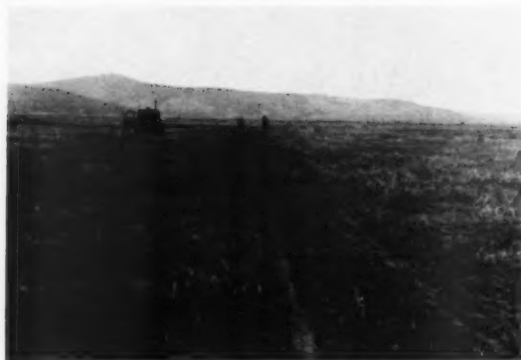
grass field touchdown...

Upon touchdown, the left main gear collapsed and the *Crusader* slid across the Morest cross deck pendants well to the left of the centerline—the tailhook failed to engage any of the pendants.

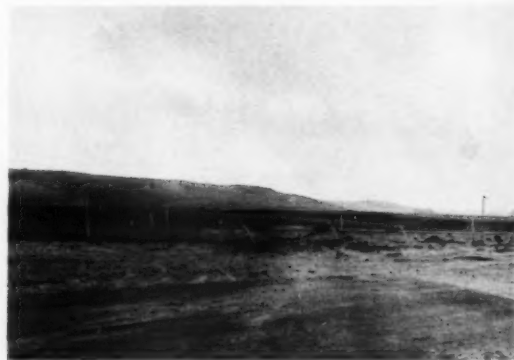
the fence...

fence collision, the port main landing gear was torn loose, the air-oil cooler line was severed and multiple gouges were incurred in the airframe and flight controls. Simultaneously with the sign collision, the afterburner finally relit. "It's a good thing," the pilot said afterwards, "I was about ready to eject!"

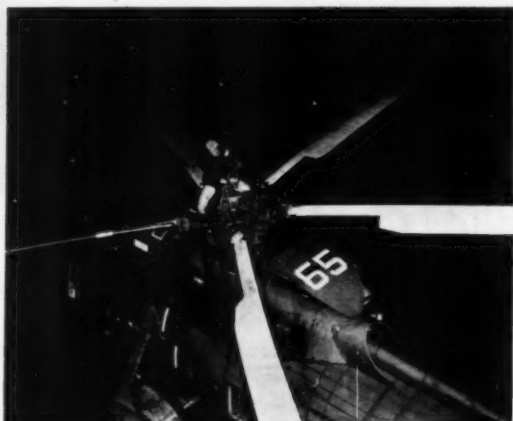
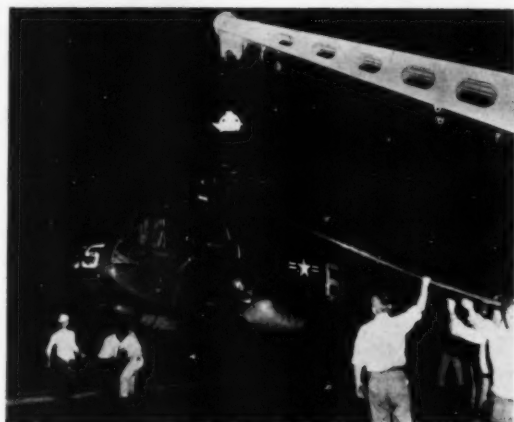
Top: Rigging the hoisting sling. Bottom: Positioning the helo on the no. 3 elevator.

- Inflate the flotation bags.
- Leave rotor blades extended to fend the helo away from the ship's hull.
- Set the rotor brake.
- Close all hatches to enhance buoyancy.
- Employ a hoisting sling comprised of materials with a minimum test strength of 70,000 lbs.
- Do not employ sharp instruments, grapnels, boathooks, etc., when handling the aircraft. Puncture of the flotation bags will surely cause the helicopter to rotate inverted and complicate the recovery.
- Utilize the Master-at-Arms force to keep the deck edge clear of spectators. Line handling crews may have to move quickly up and down the sides; spectators add an unnecessary impediment.
- Keep departmental responsibility simple as possible to insure against responsibility conflicts.

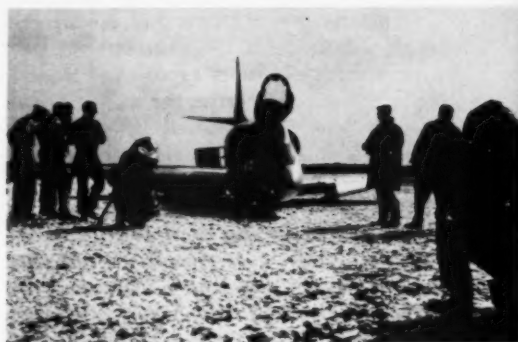
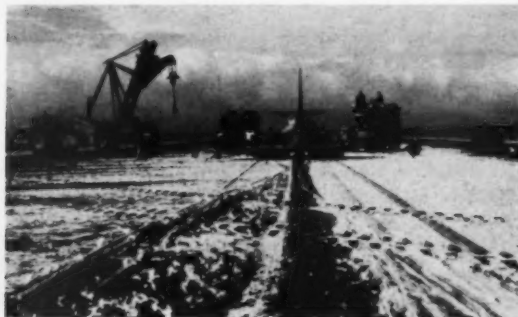
The NAS Barbers Point operations duty officer had a NATOPS Manual available and discussed by radio all the possibilities with the pilot and his wingman. After exhausting all emergency procedures, it was decided to raise the port main and nose gear and make an arrested landing on the 150-gallon centerline tank and a foamed runway. Although an LSO was not available, the wingman landed, assumed a position abeam the first arresting gear wire and coached the pilot down. The normal approach speed of 120-122 KIAS was considered too nose high an attitude so the final approach and arrestment was made at 126 KIAS. This more flat attitude was believed to reduce the nose pitch-over during the arrestment. The arrestment was smooth, the touchdown gentle, and the runout straight. The aircraft suffered very little damage.

NASC files indicate that this is the first recorded A-4 wheels-up landing on an empty centerline tank.

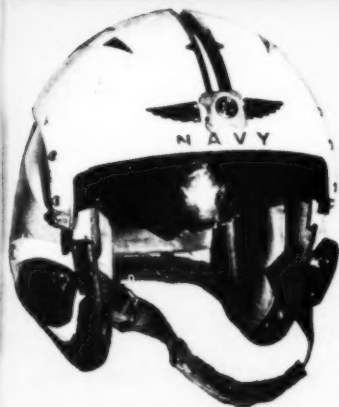
VISOR DOWN PAYS OFF: Flying glass from a canopy implosion at 21,500' at .92 IMN damaged this helmet and caused minor cuts on the pilot's face. His eyes were uninjured.

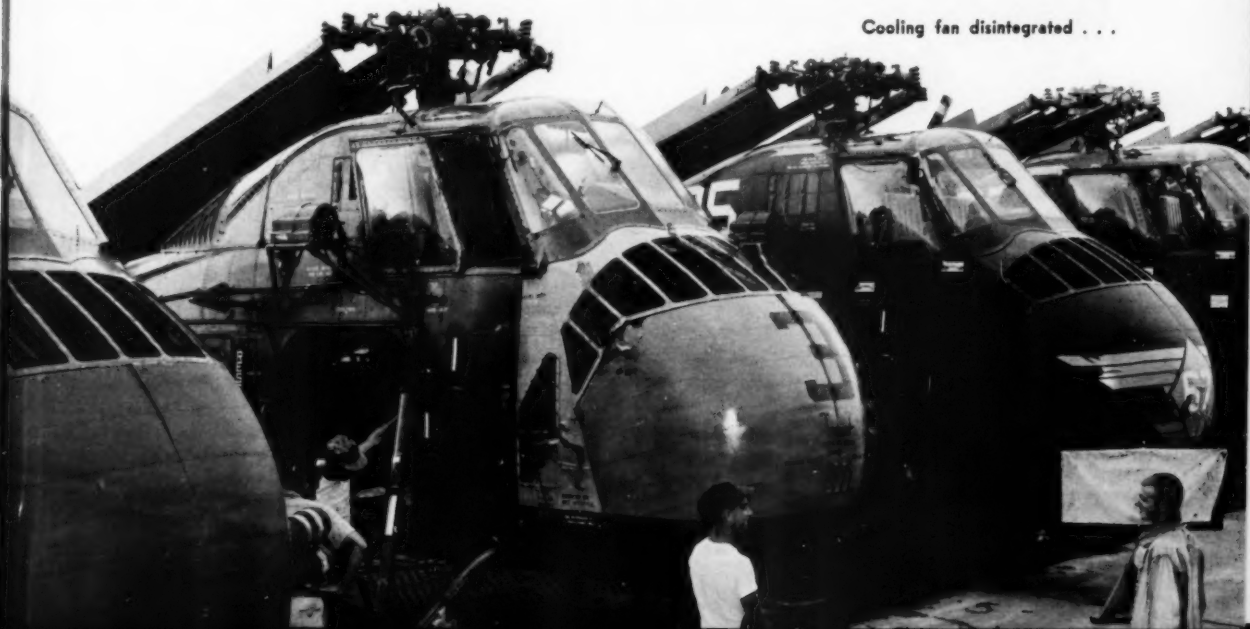
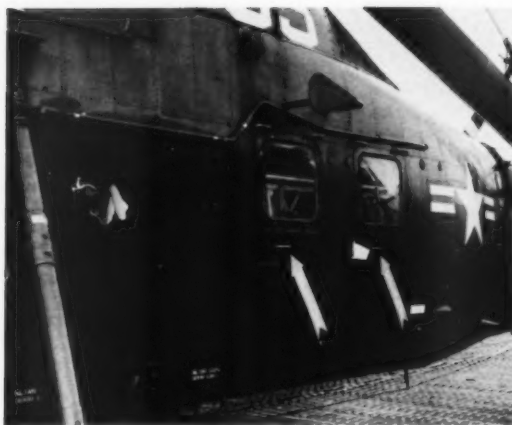
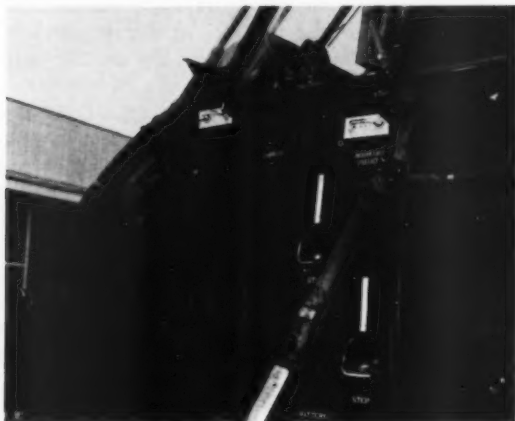
Cooling fan disintegrated . . .

Penetrated chopper to port . . .

Killed mechanic in chopper to starboard

Investigators reported the suspected cause of this mishap was the use of improper starting procedures

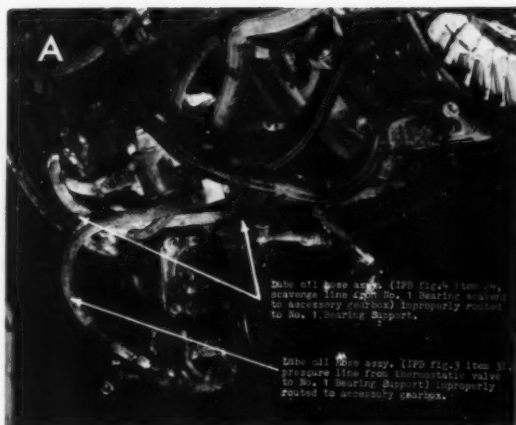
Evidence of no oil to no. 1 bearing.

This is a Murphy situation and Murphy's Law applies. Cross-connected oil lines led to failure of a J34-WE-34 engine and an inflight fire in an SP-2E.

That the engine manufacturer shorten the oil hose between the thermostatic valve and the no. 1 bearing support. Incorporation of the orifice tee and adapter (EB 340) and the knife edge filter assembly (EB 281) would permit the use of a shorter hose in this location precluding an erroneous installation.
